**DATA GAP ANALYSIS REPORT  
for TARGETED NATIONAL PRIORITY LISTING VIABILITY  
Revision 2**

**UPPER ANIMAS MINING DISTRICT  
San Juan County, Colorado  
CERCLIS ID CO0001411347**

**DATA GAP ANALYSIS – Revision 2**  
**UPPER ANIMAS MINING DISTRICT - CEMENT CREEK**  
**San Juan County, Colorado**

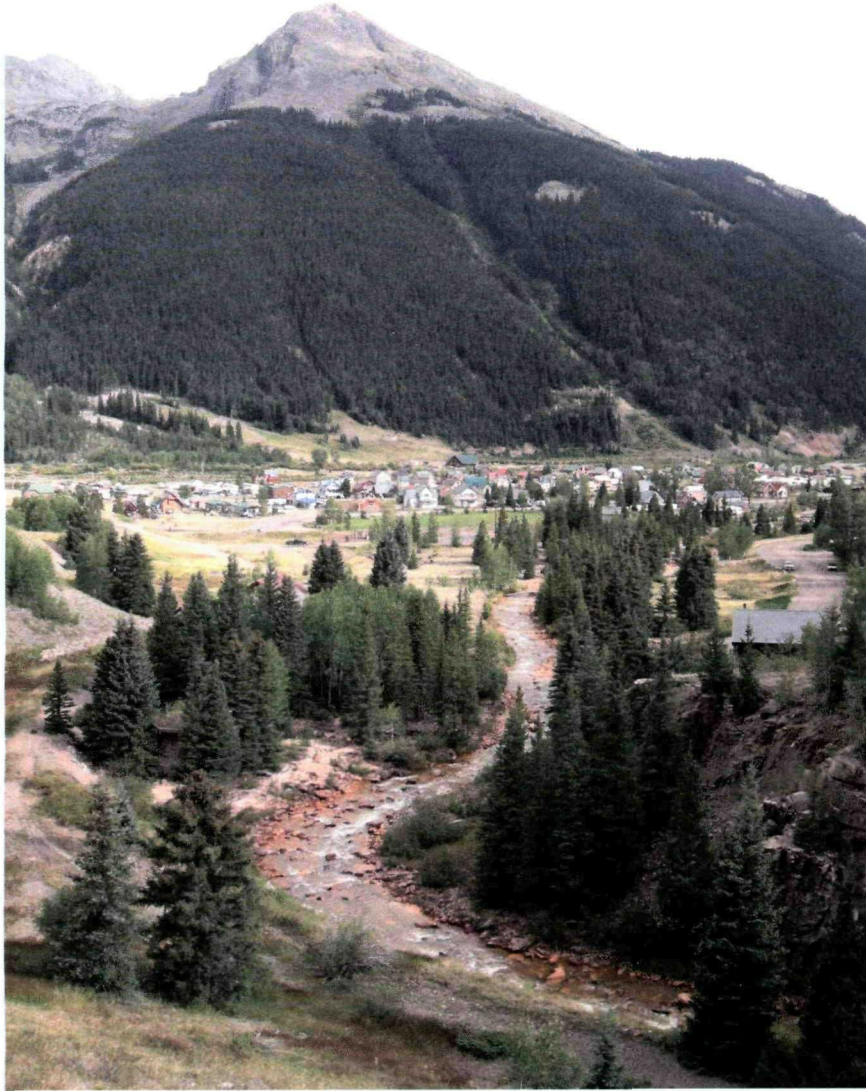
**PHOTO 1**

View to the south of Cement Creek flowing through the town of Silverton, Colorado. Note staining of stream rocks in stream bed.

with the Animas River at Silverton, Colorado (Figures 1 and 2) (Colorado Department of Public Health and Environment (CDPHE) 1998). The name Cement Creek probably refers to the iron rich precipitates (ferricrete) that coat and cement the stream bed materials (Photos 1 and 2) (USGS 2007f).

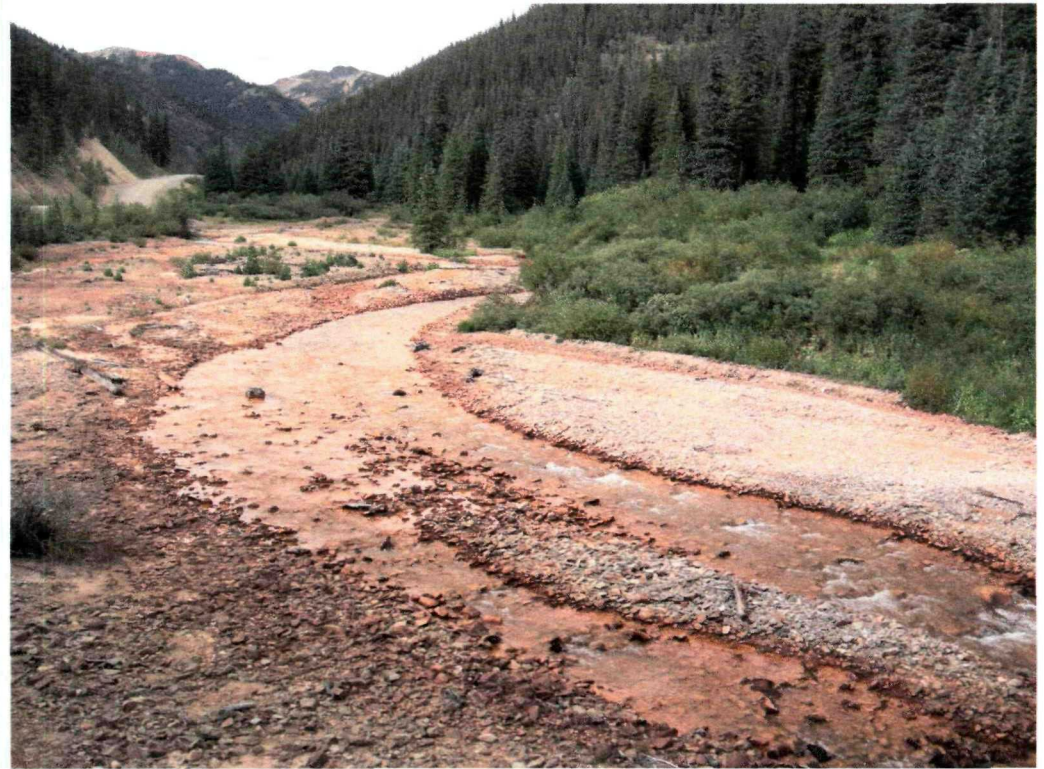
**PHOTO 2**

Streamside wetlands along upper Cement Creek below Minnesota Gulch.

Approximately 2,500 feet of streamside wetlands are found along Cement Creek (Figure 2) (Photo 2) (U.S. Department of the Interior, Fish and Wildlife Service (USDOI) 1998a; USDOI 1998c). Iron bogs are found along the middle stretch of Cement Creek. Approximately 3 miles of palustrine and riverine streamside wetlands are found along the 15-mile downstream segment of the Animas River below the probable point of entry (PPE) of Cement Creek with the Animas River (USDOI 1998b; USDOI 1998d).
